Manhole Inspection Summary

Manhole # S07KK1015MH

Insp Date: **12/23/08 4:13 PM**

Location Address: **3811 FEAR AVE**

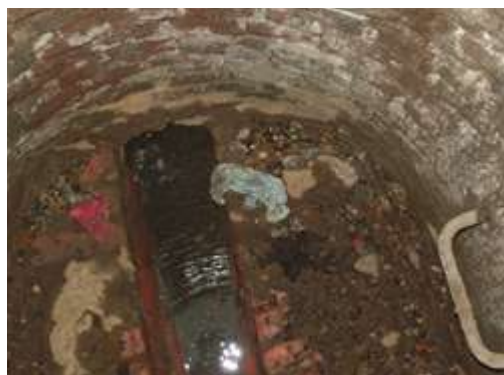
Defect 4

Condition: ☐ Sound ☐ Cracked ☐ Root Intrusion ☐ Deteriorated ☐ Leaks ☒ **Debris**

DEBRIS ON BENCH

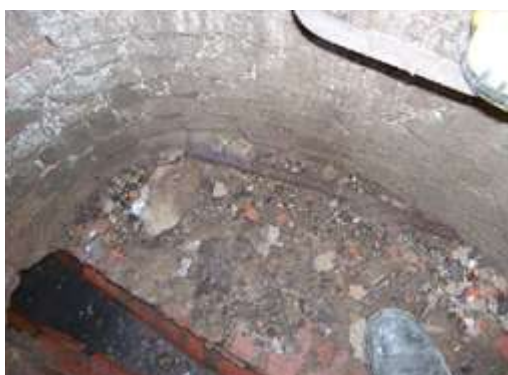
Defect 3

Surcharge ☒ **Evidence Of Surcharge** Depth: **1** (ft.) ☐ Active Surcharge Present

SURCHARGE EVIDENCE

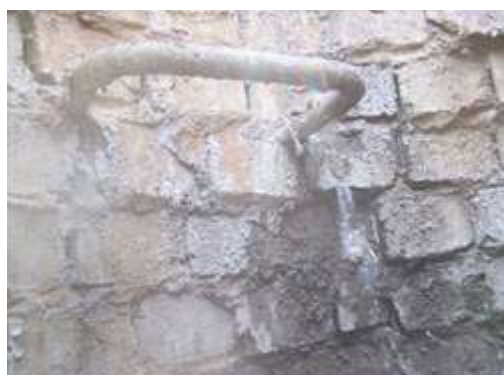
Defect 2

Infiltration: ☐ None ☐ Joint ☐ Cracks ☐ Mortar ☐ Roots ☒ **Wall**

CORBEL INFILTRATION

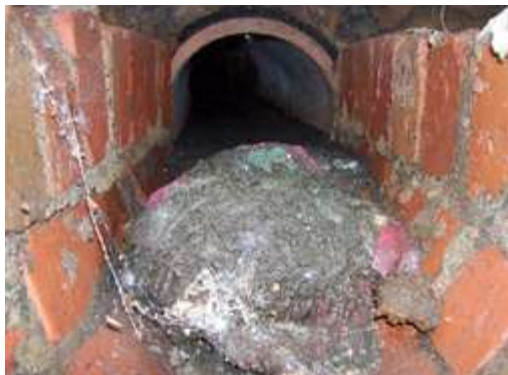
Defect 1

CHANNEL (DEBRIS)

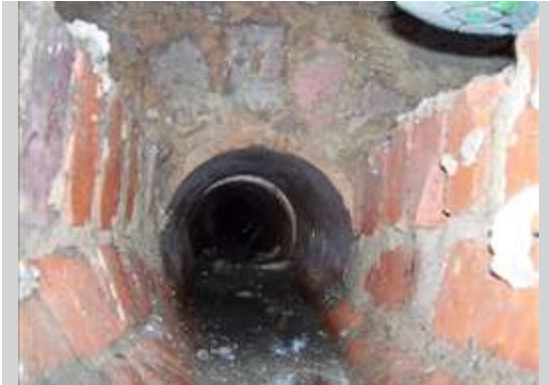
12 O'Clock Outflow

Pipe Height: (in.) Direct
Pipe Material: **Clay** ☐ Pipe Lined
Invert Depth: **7.40** (ft.) Flow Characteristics: **None**
Deposits: ☐ None ☐ Mud ☐ ~~Sludgy~~ ☒ **Debris** ☐ Grease
Silt Depth: **1** (in.) Deposits Extent: **Light**
Infiltration: **None** Pipe Seal Cond: **Sound**

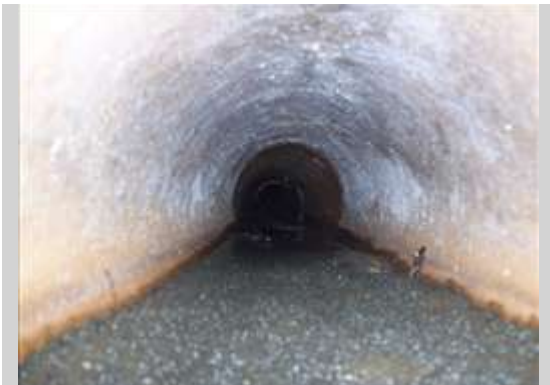
6 O'Clock Inflow

Pipe Height: (in.) Direct
Pipe Material: **Clay** ☐ Pipe Lined
Invert Depth: **7.30** (ft.) Flow Characteristics: **None**
Deposits: ☐ None ☐ Mud ☒ ~~Sludgy~~ ☒ **Debris** ☐ Grease
Silt Depth: **2** (in.) Deposits Extent: **Medium**
Infiltration: **None** Pipe Seal Cond: **Sound**
